THE LEADING EDGE

NEWSLETTER OF MUROC EAA CHAPTER 1000

August 2011

Chasing Quertrons: Troubleshooting Tales of the Unqualified

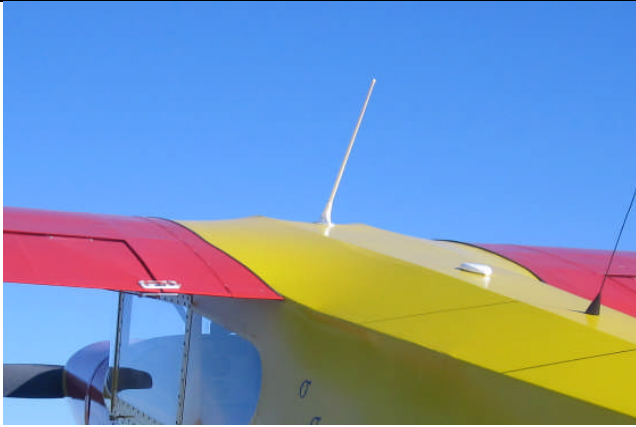
New COMANT antenna installed

(Theory #4). The forward antenna must be too close to the control head, being only about three feet away in a straight line. This is presumably closer than antennas mounted on RVs because the canopy of the RVs forces placement of the antenna farther away or underneath the fuselage on the other side of an aluminum sheet. The aft antenna on the Bearhawk was about 10 feet away from the control head, and according to the one-way R^2 rule the radiated power reaching the control head would be only about 10 percent of that from the forward antenna. That could explain why the aft antenna didn't cause a problem.

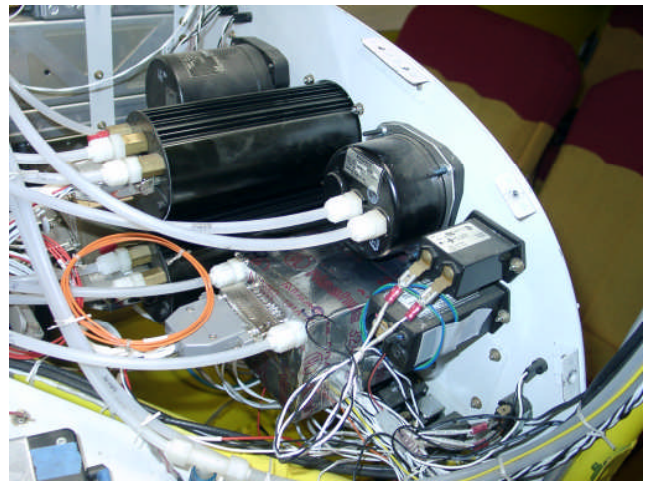
Autopilot control box wrapped in aluminum tape

The box was reinstalled and the ground test repeated. The response of the autopilot to the radio transmission was significantly reduced, enough to be considered effectively zero. Thus, the interference problem was fixed. Yay! There was much rejoicing all around. Flight tests in November 2009 showed that the pitchup with radio transmission was gone.

Based on Theory #4, the solution would seem to involve shielding the control head. Doing some more research on the Interwebs, I found that the theory of shielding was dependent on wrapping a conductor completely around the item to be shielded. If the shield is conductive in a closed loop around the item, the item is shielded. However, if the shield has a break in it, it ceases to be an effective shield. I think of it as the edges act as antennas, re-radiating the RF that the shield is trying to block. That may not be the best explanation, and I invite anyone else to submit a better explanation to this newsletter. To test the shielding idea, I wrapped some aluminum foil around the control head. While not pretty, the ground test indicated that there was a good possibility of this solution actually working.

Complicating the use of this aluminum tape was that the adhesive on it was non-conductive. Thus, to keep the shield conductive without any breaks, the control head would have to be completely wrapped using one continuous strip of tape. In the end, this wasn't that difficult to do. Five sides of the box were covered with the aluminum tape, and the tape was trimmed flush with front of the box where it contacted the instrument panel. (Foreshadowing: The last half of that sentence would prevent this from being a complete solution.) The stickers on the box, such as the serial number and the warranty seal, were covered in plastic to prevent the tape from sticking to the stickers, just in case the tape would have to be removed. Prior to taping, photos were taken of the stickers to retain the information.

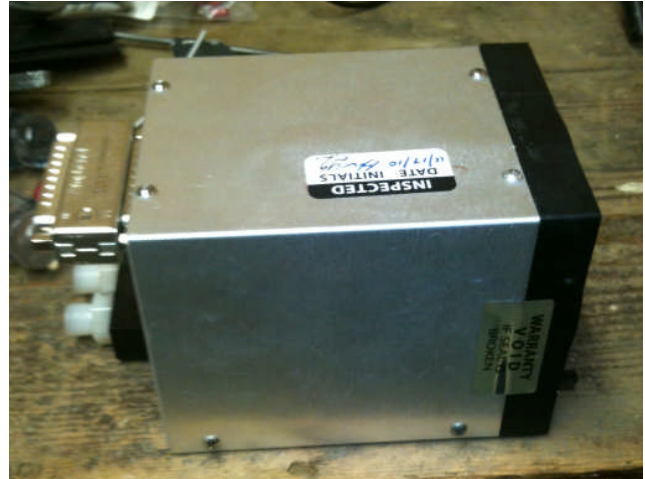
Soon thereafter I removed the control head, removed the aluminum tape, and shipped it back to TruTrak. They made some modifications to one of the circuit boards and completely replaced another circuit board to bring my unit up to the current design. Finally they installed a metal case. They told me that normally they charge \$400 for the service done, but since this was to address a problem that had existed for a long time, they cut me a deal for only \$250. The control head was soon returned and reinstalled. Again, with great hope, I ran the ground test, and...the pitchup remained. Krap! Now what?

New metal case with RF filter connector mounted to DB25 connector

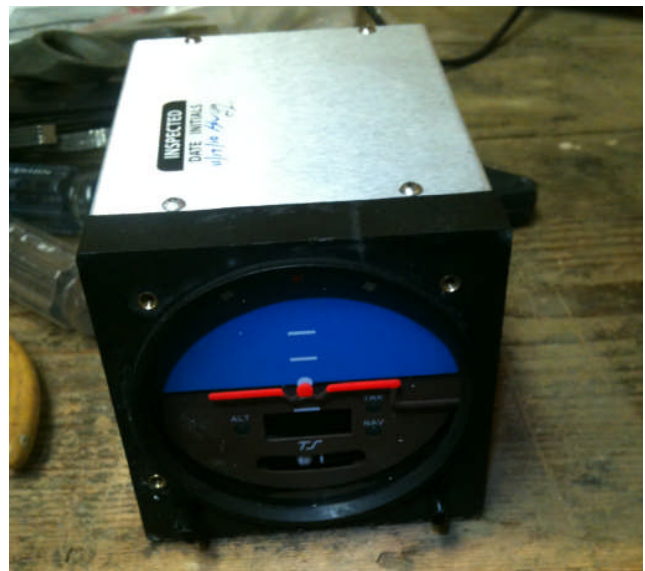
While moving the antenna around and trying to make sense of the test results, I started to wonder if the aluminum instrument panel could be responding to the RF energy. The metal box around the autopilot did not extend all of the way to the instrument panel, but stopped about 3/4 inch short of the instrument panel because of the plastic faceplate. I wondered if this gap in the shielding could somehow be funneling the RF energy into the control head.

I disconnected the control head from the instrument panel and tried the ground test with the control head at different distances from the instrument panel. Changing the distance from the instrument panel changed the response of the autopilot to transmissions. This made me think I was on to something. Perhaps the problem was that the metal shield box wasn't grounded (or electrically bonded) to the instrument panel (Theory #6).

Plastic faceplate which gave an entry path for RF interference

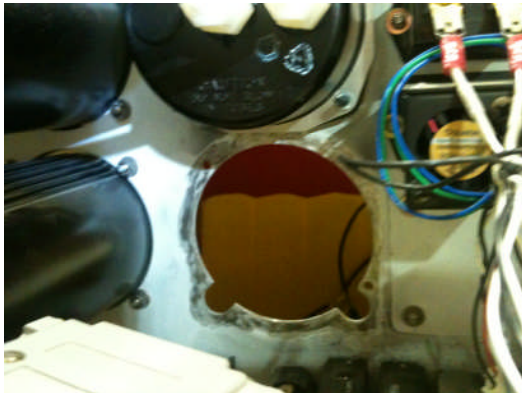
Autopilot mounting hole with non-conductive paint removed

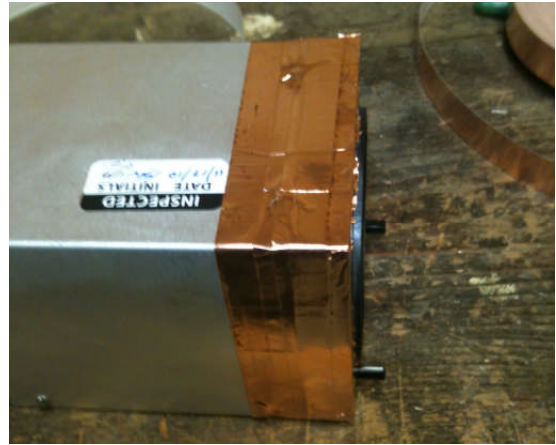
So what happened with the aluminum tape? Why did it work sometimes and not other times? The final answer was a combination of Theories #4 and #6. The control head needed to be shielded, and that shield needed to be electrically connected to the instrument panel. The aluminum tape was trimmed off right at the edge where it would contact the instrument panel. If the aluminum tape happened to be in electrical contact with the instrument panel, the shield worked. However, if vibration or other causes broke that electrical connection, the shield stopped working and the interference problem returned. This would explain how the problem seemed to fix itself in flight--the aluminum tape came back into contact with the

Copper tape bridging the gap between the metal case and instrument panel

While researching solutions, I came across a roll of copper tape with electrically conductive adhesive (www.amazon.com, part number CFL-5CA/COP07536). I purchased one and used it to wrap the plastic faceplate of the control head. I wrapped from the metal box across the plastic faceplate and around onto the front of the faceplate so that it would contact the instrument panel. The paint was removed from the contact area on the back of the instrument panel. Thus the copper tape with the conductive adhesive formed an electrical connection between the instrument panel and the metal box on the control head, making a complete shield. The control head was reinstalled and the ground test repeated. This time...absolutely no response from the autopilot while transmitting on the radio. Success at last! Subsequent flight testing confirmed that the EMI Dragon had finally been slain!

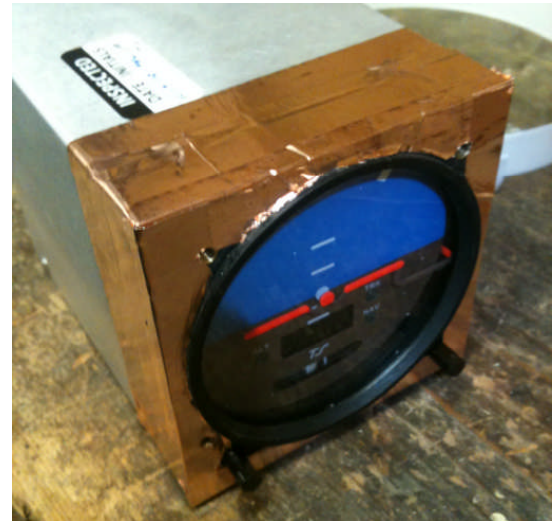
instrument panel. Had I thought to wrap the aluminum tape around the front of the control head so that it would contact the panel, the aluminum tape would have been the final answer. As it was, the copper tape with the conductive adhesive was a better solution because it was easier to get the required electrical contact.

Copper tape wrapped onto front of case to connect with instrument panel
